COMPOSITE STANDS

INSPECTION GUIDE

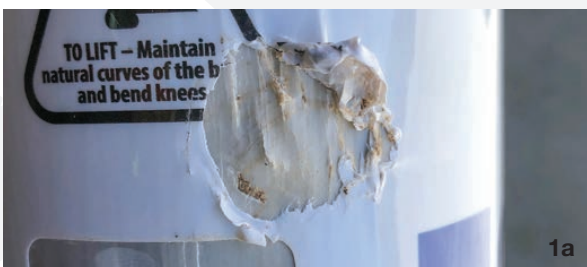
1a

(1a) It is clear that the support stand has been impacted. As you can see, the vinyl label has been damaged and delamination has occurred in the area. While the damaged specimen passed a WLL test, ANY SUPPORT STAND with this type of damage SHALL NOT be used.

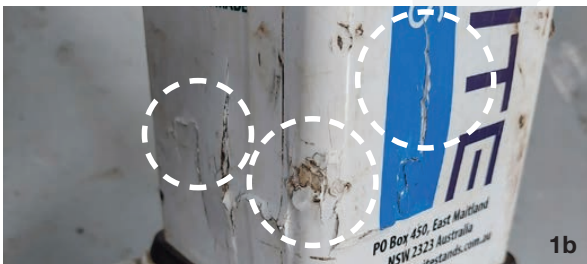
1b

(1b) Indicates visual signs of impact damage on the corner of the column, note the patch of vinyl missing in the impact area, and the splitting in the vinyl where the column has delaminated. Any support stand displaying this type of damage SHALL NOT be used.

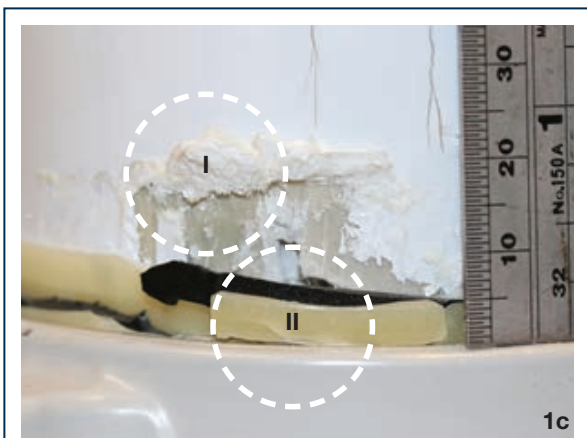
1c

(1c) Offers three (3) different examples that users should be trained to look for during pre-use inspections:

- I. Riffeling of the vinyl label at the base of the support stand where the composite column connects to the stand base. This is a sign of improper use in the form of overloading, excessive side loading or having applied excessive rotational forces to the column or dynamic (shock) load the support stand.
- II. Note the damage to the black plastic boot. This can also be a sign of improper use in the form of overloading, excessive side loading or having applied excessive rotational forces to the column or shock loading the support stand.
- III. The inner surface of the 15-tonne composite column should be visually inspected. Invert the support stand to inspect the column inner surface between the filled section of column and the base of the support stand for any signs of delamination.

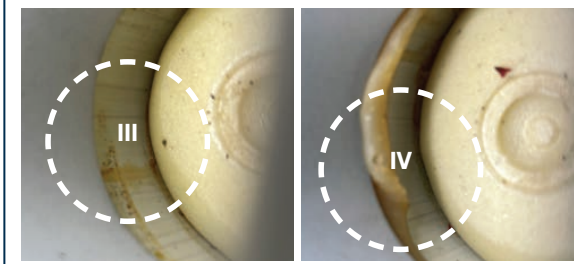
IV

N.B. Resin may be observed on the edges of the inner area of the base, see image IV. This is residual material from the assembly process. This is normal and not a reason for concern.

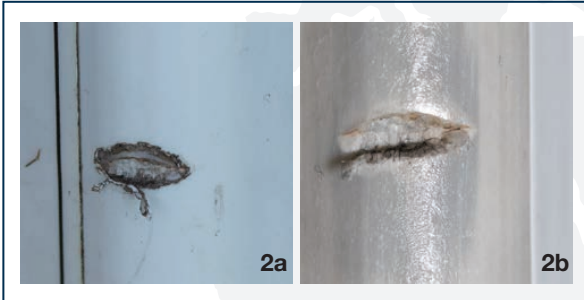
- Photos **(2a and 2b)** are examples of concentrated damage to a composite column that is greater than 1mm deep. Even though there are no signs of delamination, this level of damage should be referred to your local distributor prior to using the support stand.

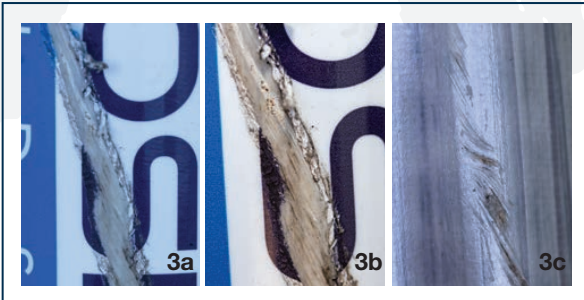
- Should damage to the composite column be identified, the vinyl label can be removed to assess the damage to the composite material properly. In this example, visual damage appears significant **(3a and 3b)** however, with the label removed **(3c)**, there was only minor damage to the column (less than 0.5mm) with no signs of delamination. This unit passed a WLL test.

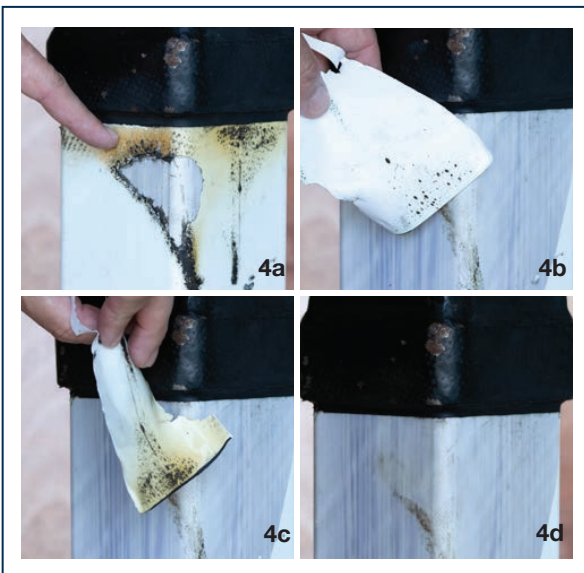
- COMPOSITE STANDS are not ideally suited to hot work and have an operating temperature range of between -15°C and 75°C. Visible signs of heat damage **(4a)** will appear in the vinyl label long before the composite material is compromised.
