COMPOSITE STANDS

INSPECTION GUIDE

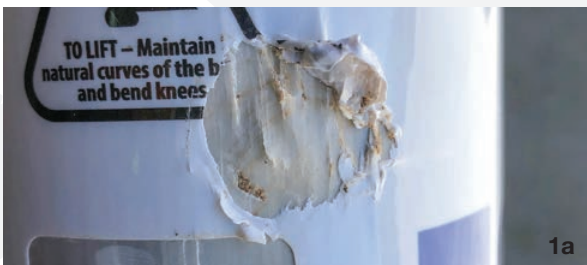
(1a) It is clear that the jack stand has been impacted. As you can see, the vinyl label has been damaged and delamination has occurred in the area. While the damaged specimen passed a WLL test, ANY JACK STAND with this type of damage SHALL NOT be used.

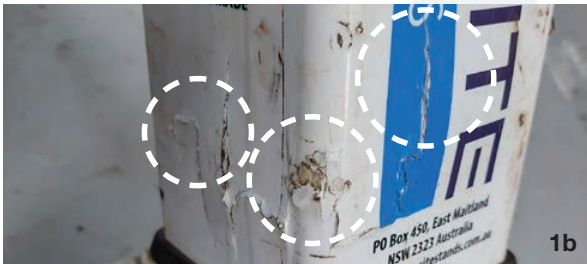
(1b) Indicates visual signs of impact damage on the corner of the column, note the patch of vinyl missing in the impact area, and the splitting in the vinyl where the column has delaminated. Any stand displaying this type of damage SHALL NOT be used.

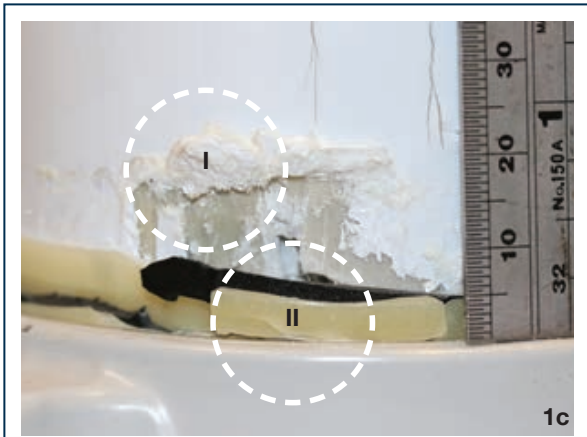
(1c) Offers three (3) different examples that users should be trained to look for during pre-use inspections:

- I. Riffeling of the vinyl label at the base of the stand where the composite column connects to the stand base. This is a sign of improper use in the form of overloading, excessive side loading or having applied excessive rotational forces to the column or dynamic (shock) load the stand.
- II. Note the damage to the black plastic boot. This can also be a sign of improper use in the form of overloading, excessive side loading or having applied excessive rotational forces to the column or shock loading the stand.
- III. The inner surface of the 15-tonne composite column should be visually inspected. Invert the stand to inspect the column inner surface between the filled section of column and the base of the stand for any signs of delamination.

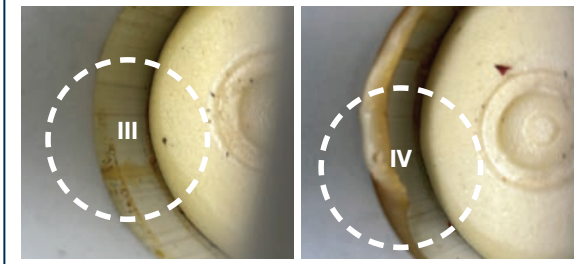
N.B. Resin may be observed on the edges of the inner area of the base, see image IV. This is residual material from the assembly process. This is normal and not a reason for concern.

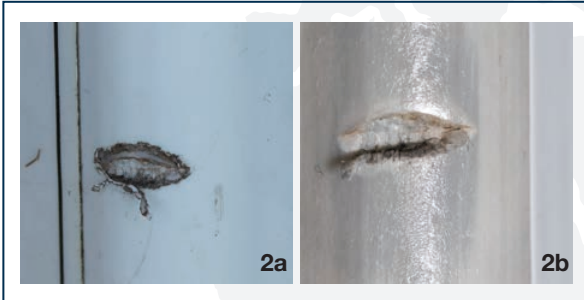
Photos **(2a and 2b)** are examples of concentrated damage to a composite column that is greater than 1mm deep. Even though there are no signs of delamination, this level of damage should be referred to your local distributor prior to using the jack stand.

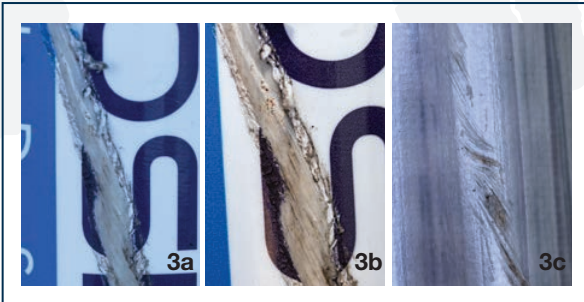
Should damage to the composite column be identified, the vinyl label can be removed to assess the damage to the composite material properly. In this example, visual damage appears significant **(3a and 3b)** however, with the label removed **(3c)**, there was only minor damage to the column (less than 0.5mm) with no signs of delamination. This unit passed a WLL test.

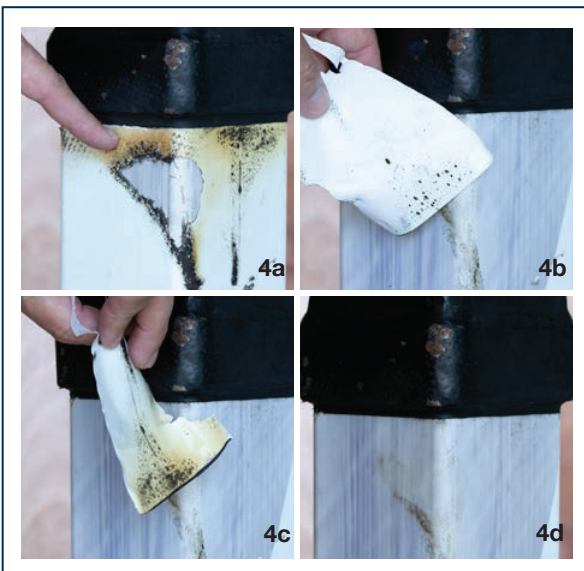
COMPOSITE STANDS are not ideally suited to hot work and have an operating temperature range of between -15°C and 75°C. Visible signs of heat damage **(4a)** will appear in the vinyl label long before the composite material is compromised.
