# COMPOSITE STANDS

## INSPECTION GUIDE

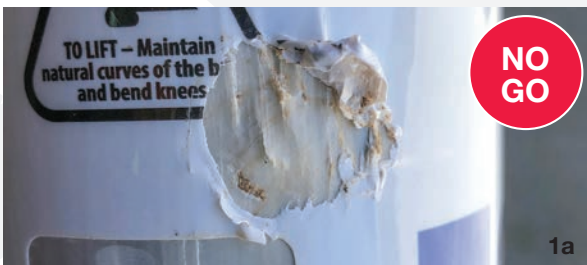
**(1a)** It is clear that the support stand has been impacted. As you can see, the vinyl label has been damaged and delamination has occurred in the area. While the damaged specimen passed a WLL test, ANY SUPPORT STAND with this type of damage SHALL NOT be used.

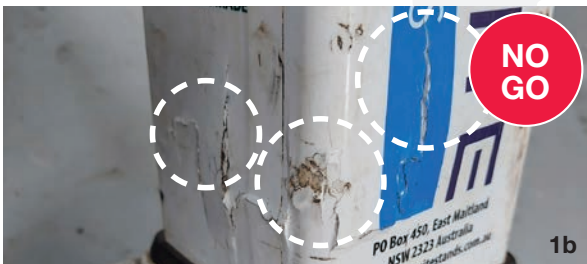
**(1b)** Indicates visual signs of impact damage on the corner of the column, note the patch of vinyl missing in the impact area, and the splitting in the vinyl where the column has delaminated. Any support stand displaying this type of damage SHALL NOT be used.

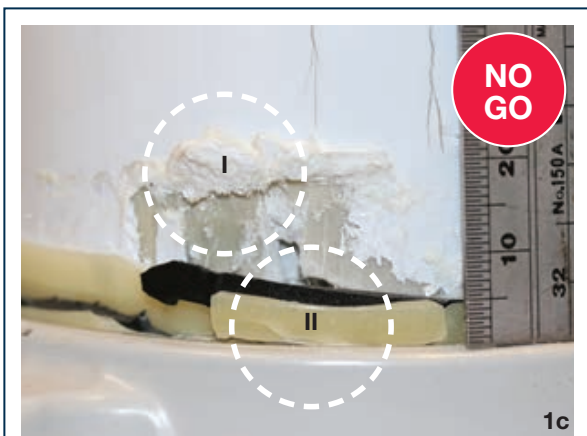
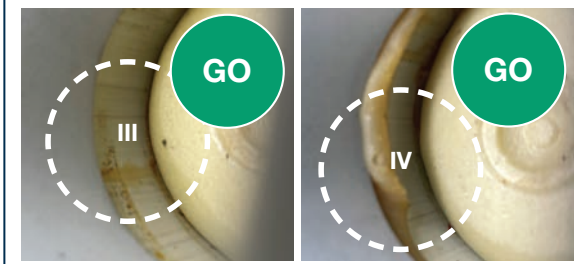
**(1c)** Offers three (3) different examples that users should be trained to look for during pre-use inspections:

- I. Riffeling of the vinyl label at the base of the support stand where the composite column connects to the stand base. This is a sign of improper use in the form of overloading, excessive side loading or having applied excessive rotational forces to the column or dynamic (shock) load the support stand.
- II. Note the damage to the black plastic boot. This can also be a sign of improper use in the form of overloading, excessive side loading or having applied excessive rotational forces to the column or shock loading the support stand.
- III. The inner surface of the 15-tonne composite column should be visually inspected. Invert the support stand to inspect the column inner surface between the filled section of column and the base of the support stand for any signs of delamination.

**N.B.** Resin may be observed on the edges of the inner area of the base, see image IV. This is residual material from the assembly process. This is normal and not a reason for concern.

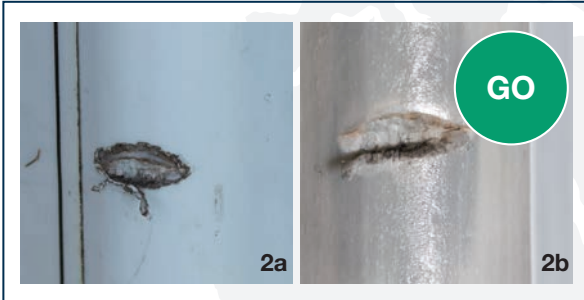
- Photos **(2a and 2b)** are examples of concentrated damage to a composite column that is greater than 1mm deep. Even though there are no signs of delamination, this level of damage should be referred to your local distributor prior to using the support stand.

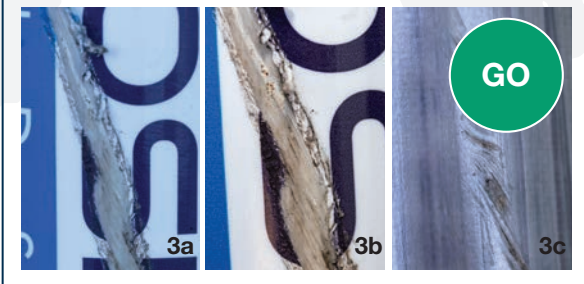
- Should damage to the composite column be identified, the vinyl label can be removed to assess the damage to the composite material properly. In this example, visual damage appears significant **(3a and 3b)** however, with the label removed **(3c)**, there was only minor damage to the column (less than 0.5mm) with no signs of delamination. This unit passed a WLL test.

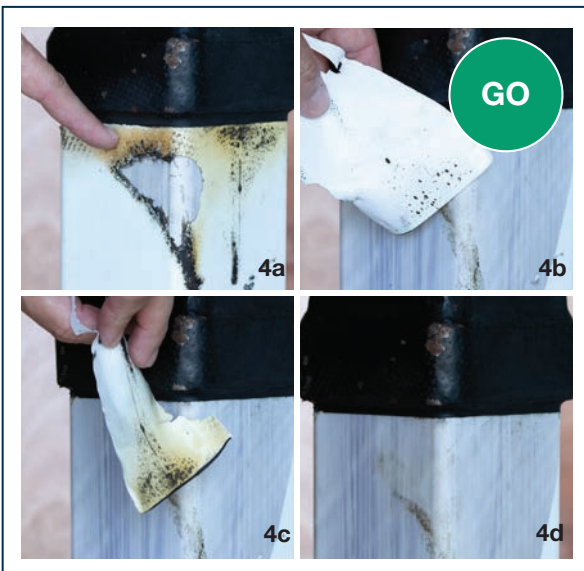
- COMPOSITE STANDS are not ideally suited to hot work and have an operating temperature range of between -15°C and 75°C. Visible signs of heat damage **(4a)** will appear in the vinyl label long before the composite material is compromised.
